# Manhole Inspection Summary

Manhole # S17EE2004MH

Insp Date: **10/19/06 2:33 PM**

**Location** Address: **1861 SULGRAVE AVE**

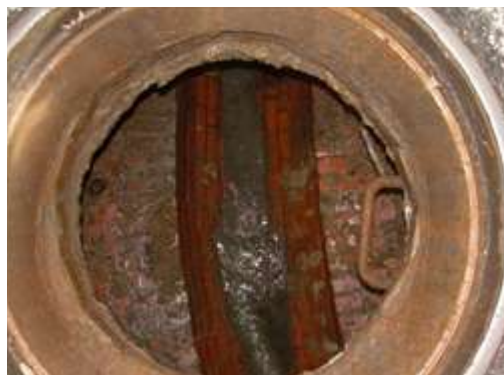
Top View

Corroded steps. Bench debris.

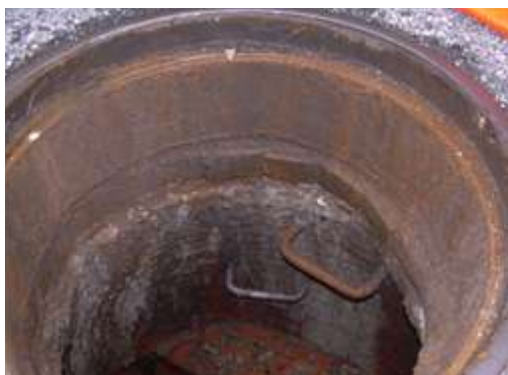
Defect

Frame offset. Frame leaks. Adjustment deterioration and infiltration - other side.

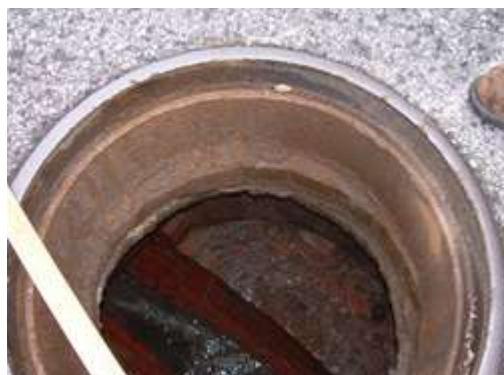
Defect

Frame offset. Frame leaks. Adjustment infiltration.

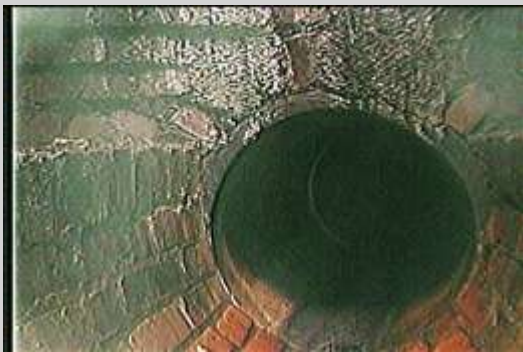
### 18 in. Circular Gravity Sewer Pipe Out @ 12 O'Clock

Pipe Material: **Clay** ☐ Pipe Lined

Invert Depth: **6.32** (ft.) Flow Characteristics: **Slow**

Infiltration: **None** Pipe Seal Cond: **Unknown**

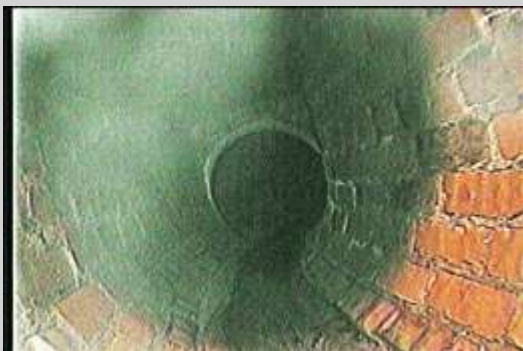
### 18 in. Circular Gravity Sewer Pipe In @ 6 O'Clock

Pipe Material: **Clay** ☐ Pipe Lined

Invert Depth: **6.03** (ft.) Flow Characteristics: **Slow**

Infiltration: **None** Pipe Seal Cond: **Unknown**
